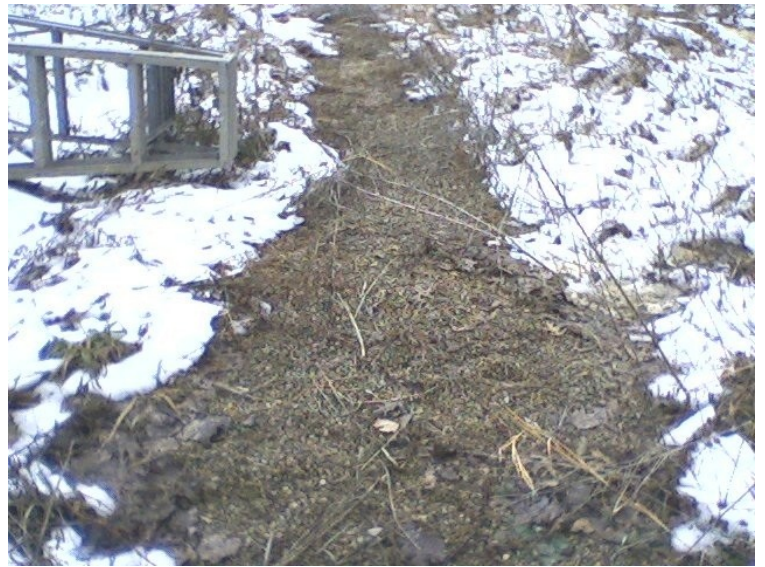
0127111508.jpg

(Above) The Constructed Wetlands is deeper in the stone than warm water designing and the microbial action has been quite effective. Testing shows that in spite of extremely cold weather prior to the testing (in December) the wetlands cleaned the effluent so that at the outlet end the finished water was still winter-warm – a microbe action adequate warmth of 42 degrees Fahrenheit, not freezing or subfreezing like outdoors above ground.

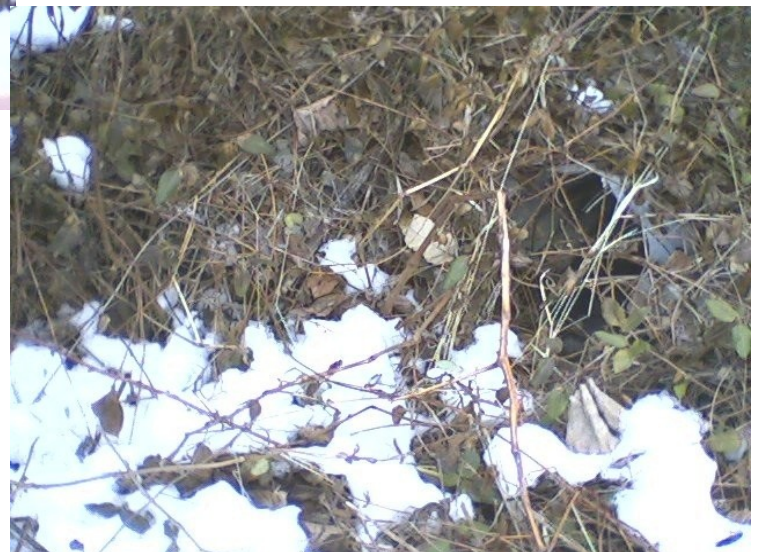
0127111503.jpg

(Below) Clearly the combination of high seasonal ground water and twice the usual amount of rain has contributed a significant amount of rain water to our woodlands swales.

The farmer who had worked these now-woodlands, back many years ago had bequeathed our lot with nice swales running parallel exactly 25 feet apart.

Now interrupted by the house island and perimeter swale, the Raichyk habitat has added small pools at the edges to expand the capacity of the swales, to provide landscape interest and habitat improvements for the small fauna and visiting birds.

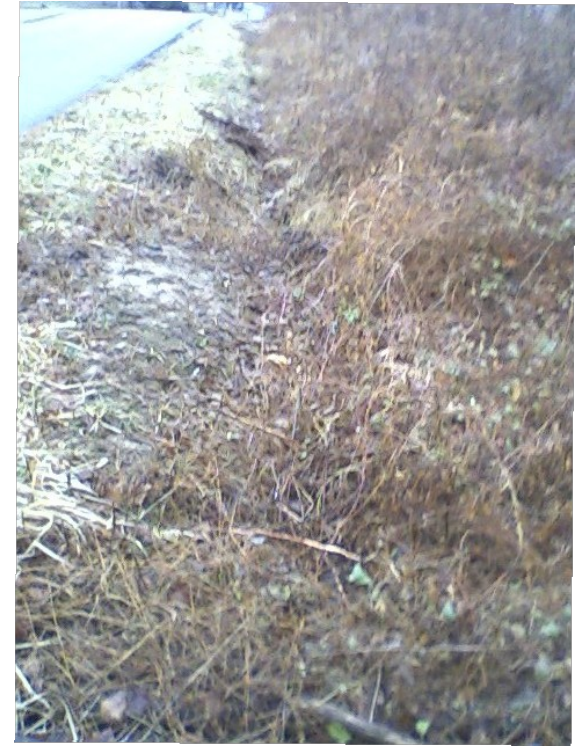
0228111206a.jpg

(Above) In winter, the strong concern is the seasonally high ground water in our area. Yet when studying the weather data, it was clear that the winter was also a low precipitation period.

These photos, in February were after a snow melt, a two day rain sequence of at least 0.9 inch rain in a month that had more than double the average February precipitation.

The road ditch above shows that our lot contributes nearly no rain since most in the ditch is likely from the road.

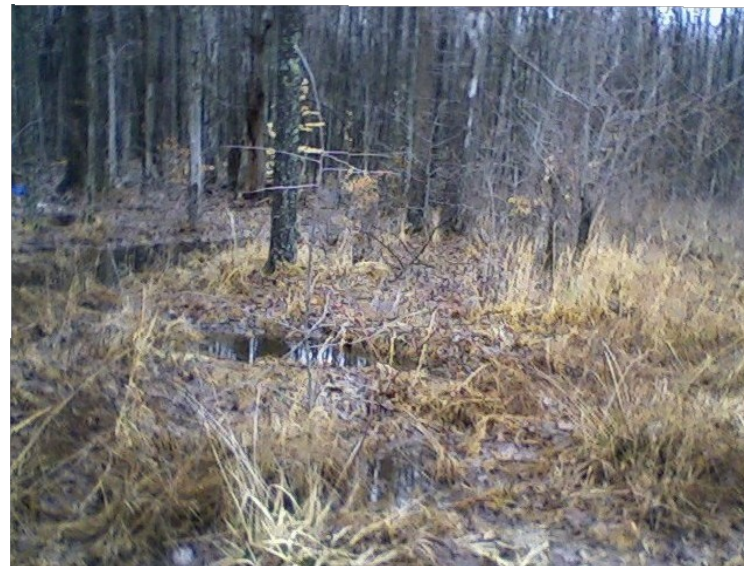
0228111258a.jpg

(Above) This is the stretch of road ditch downstream from our driveway and culvert.

Even with the unusual extremely wet winter conditions, the road ditch shows that our lot is managing to process the rainwater right along with the high groundwater.

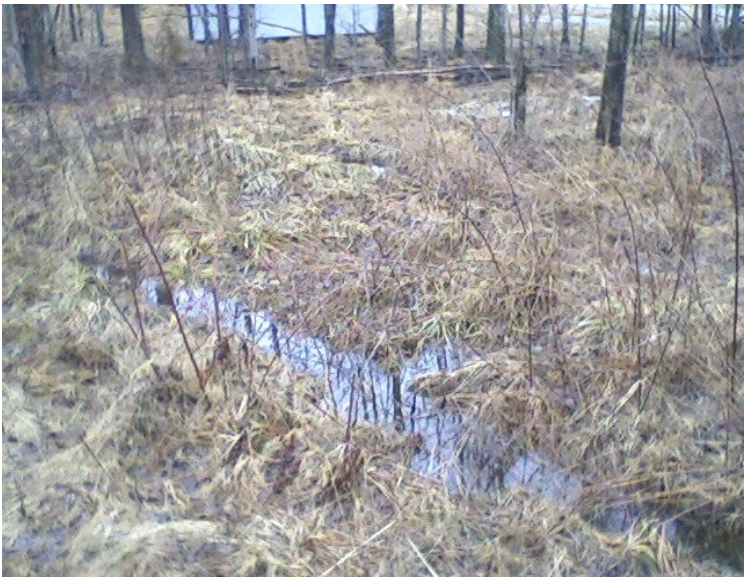
0228111307b.jpg

<-- The open creeklet that collects the house-roof runoff, keeps that area around the house drained and isolates the composting island extends the whole length of the home.

This end is near the frog pool and its adjacent dispersal wings.

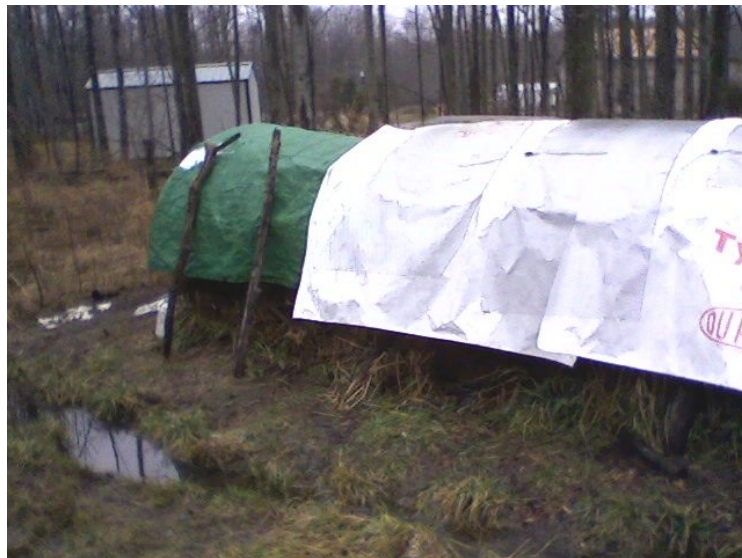
0228111305a.jpg

(Above right) Clearly the thermophilic composting bins are well protected from the wet weather extremes.

The overall average wetness of the Brown County area is perfect for normal thermophilic composting without such sheltering, but the extreme weather events makes simple tarp coverage sensible for disruption protection.

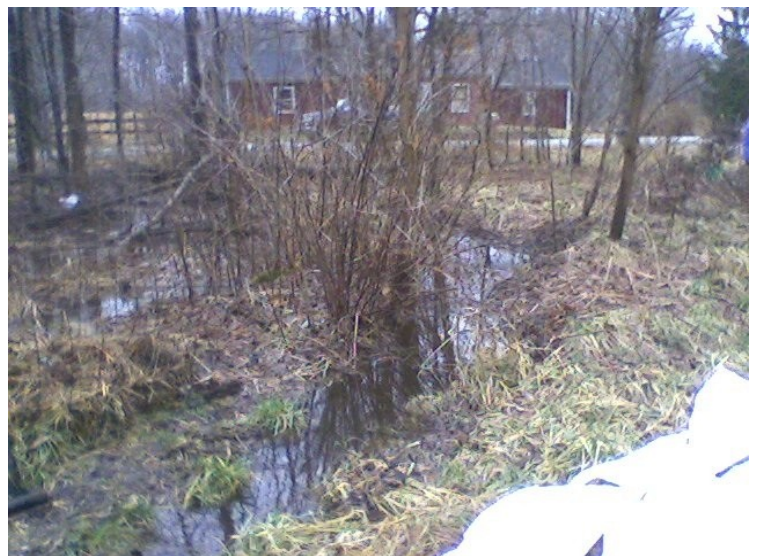
022811157a.jpg

(Right) The open creeklet trails toward the slope to the road ditch, and has been dredged to allow water in the creeklet to drain IF it reaches high enough on the level ground.

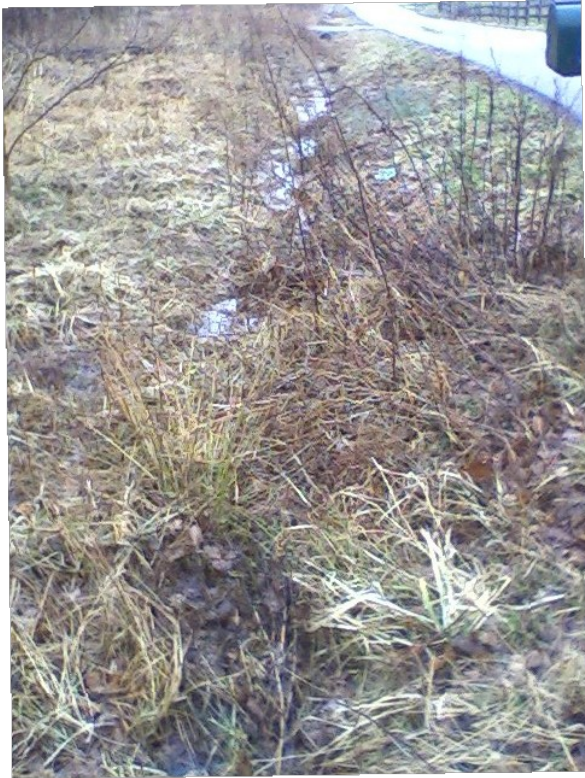
0309111119.jpg

Raichyk
front road
ditch after
extreme
rain on
3/9/2011

Compared to what
the extreme rain
did to the neighbors
on similar flat lot.

Considering the amount of rainwater that fell and flooded the neighbor's flat lot, with no plan of management, shows that the water in the Raichyk front road ditch, the public right of way area, is strictly a small portion of the rain that fell on the Raichyk's very flat lot.

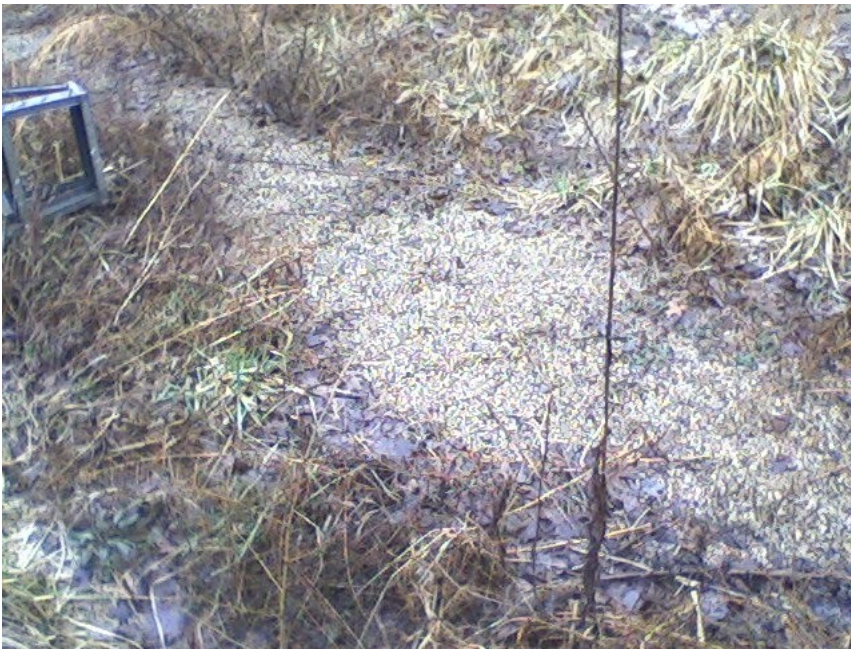
0309111403.jpg

Constructed Wetlands
unaffected.

Driveway culvert at right below
shows very little rainwater is
leaving our lot to go further
down the road.

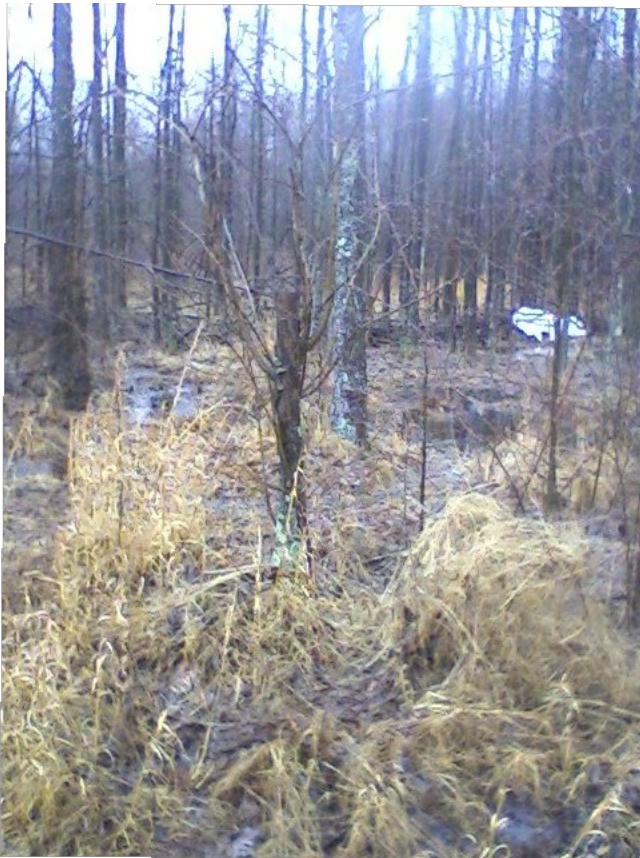
0309111417.jpg

Woodlands soaking wet, watershed
diverted from constructed wetlands.

Raincreeklet around house island
nearly full. Compost bins high & dry

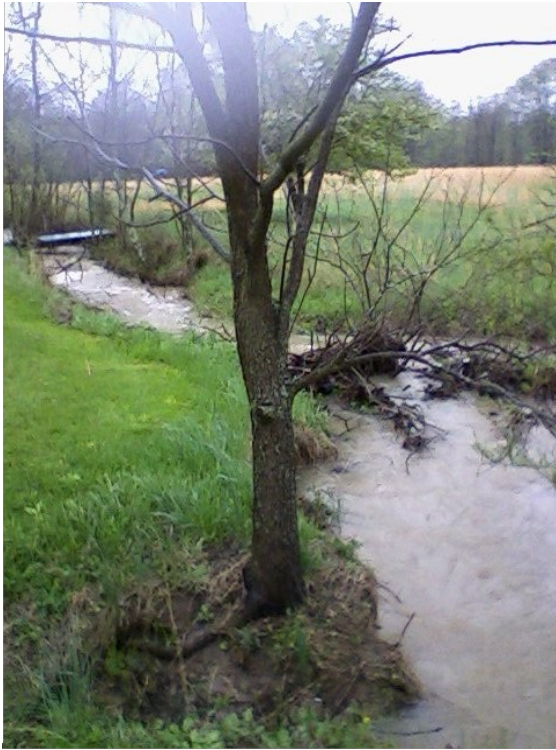
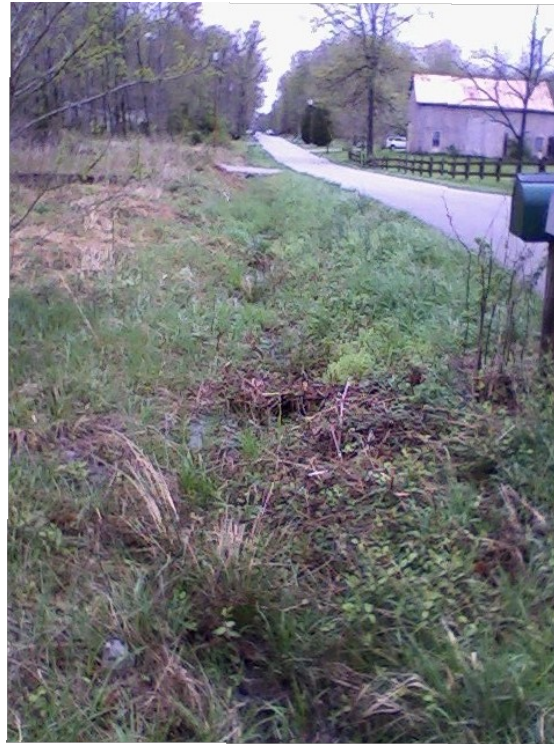
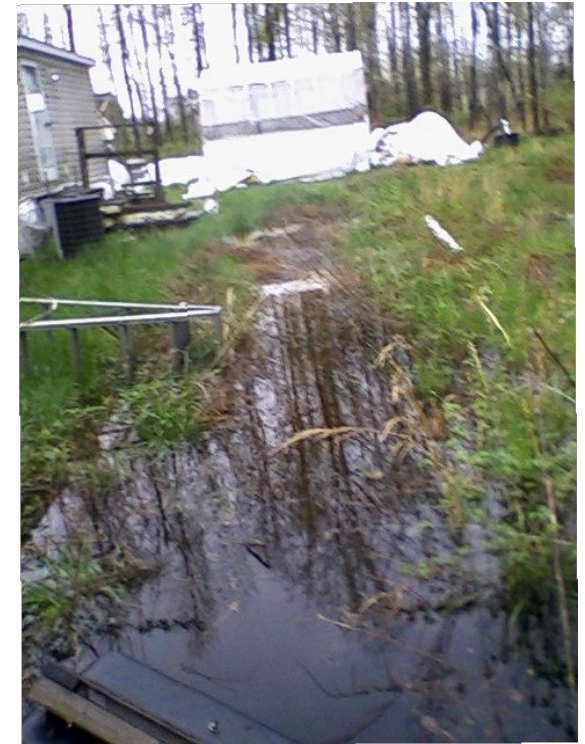
(Clockwise from above) Neighbors' creek across the road on child- and pet-endangering rampage, due to supersaturated soils + heavy day's rain again... AND due to constant mowing. Trees on banks are near washing away

Not however due to Raichyk contribution, see road ditch next. Stormwater from Raichyk's lot is sequestered and diverted to habitat pools. Constructed wetlands with highwater held by safety banks. Woodlands watershed diverted to side-of-driveway ponds. Tarp-covered Equipment&Materials Storage, House and Sunshed are unscathed even by highwinds.

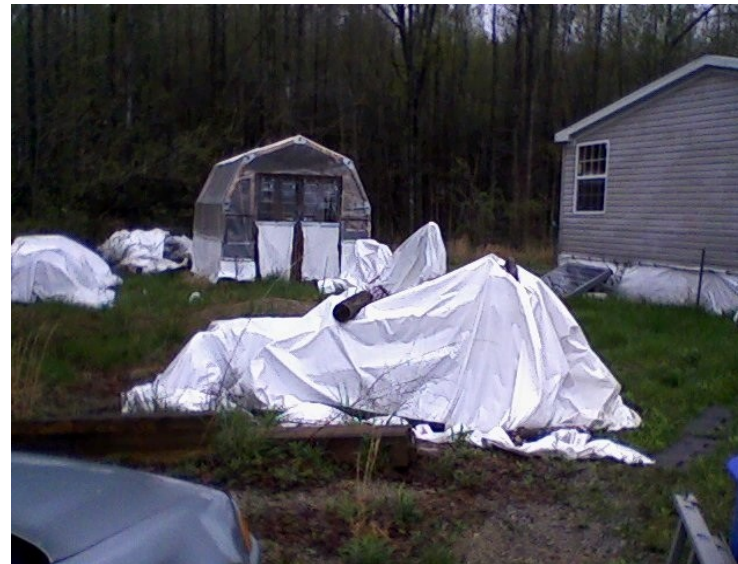
0420110849.jpg

With the April combination of supersaturated soils – from the previous couple of weeks of very ample spring rains – with the rapid downpour of the night-earlyAM of April 20th, the system's built-in overflow handling was pretty well tested.

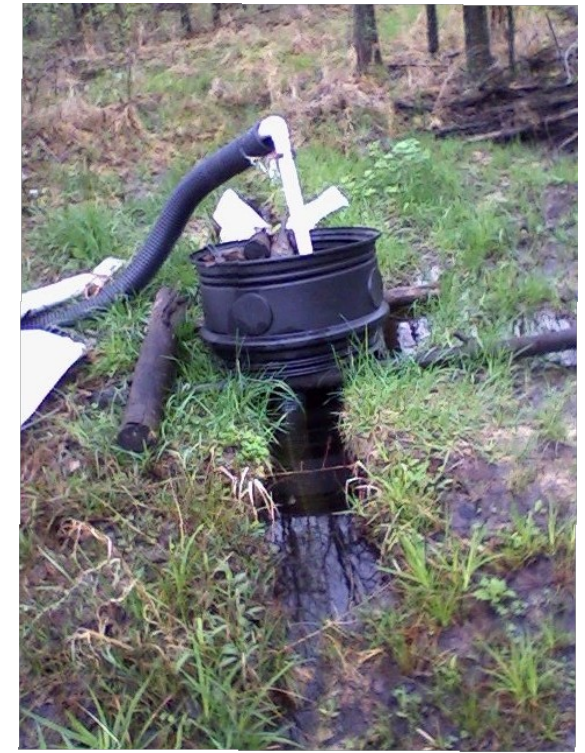
0420110845.jpg

The vernal pool – another habitat feature with overflow control protection – had expanded into a second cell, creating the elongated chain of pools -->

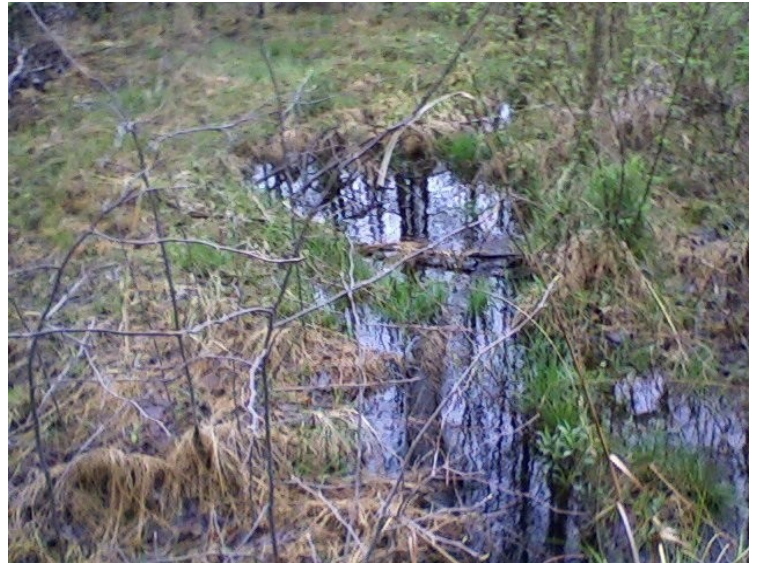
0420110838.jpg

The open creeklet separating the composting bin island from the house island was definitely full, yet the islands were adequately protected from excessive stormwater.

Trial and error in designing the labyrinth of stone-filled channels for rain control as it rushes off the house roof is suitable for a sensible incrementally improving approach to custom design of stormwater provided the designers/implementers are on-site for the naturally unschedulable observations needed. As would be the case for homeowners/DIY with appropriate variance.

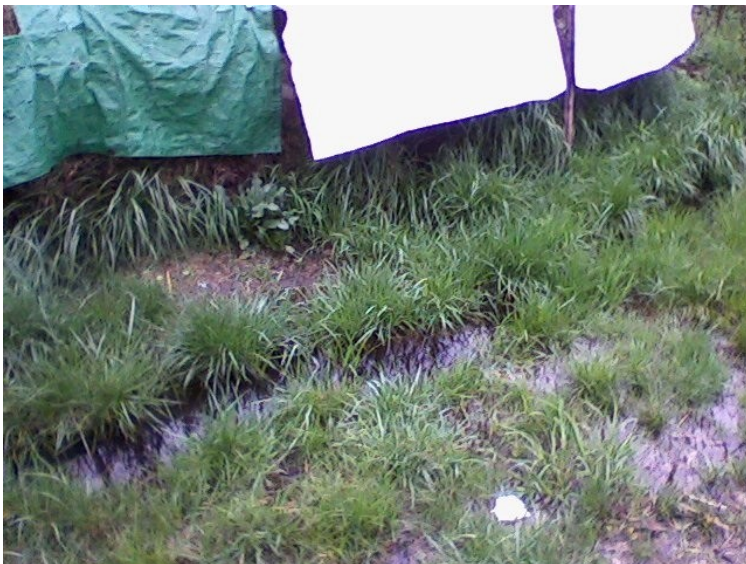
0420110835.jpg

Open creeklet – seen above also – that protects the compost bin island from the house-roof runoff, trails along the backside of the bird sanctuary area (hummingbird and finch habitat and natural landscape plantings) curves toward the Avonburg soil areas on its way to the road ditch.

This allows expanding time for stormwater to soak in when the rain is more normal, but allows the relief needed for the house-island and composting island to remain unflooded.

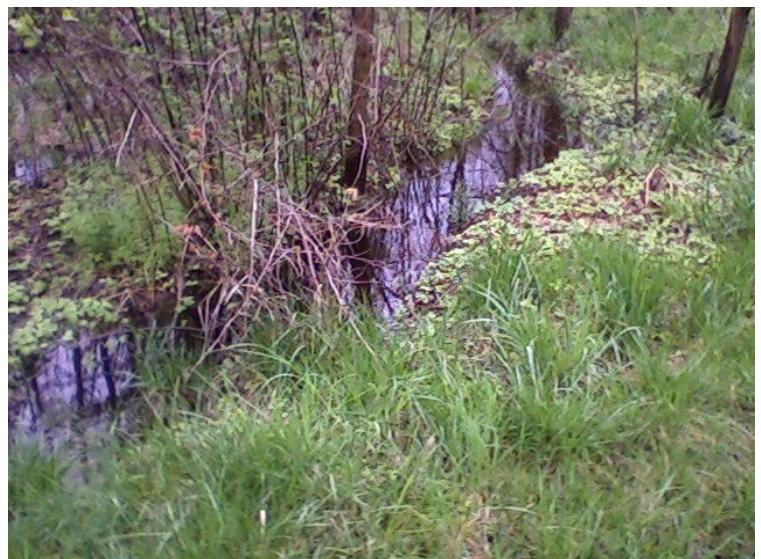
0420110830.jpg

It further provides visual interest in the landscape between the house and the less desirable views of traffic and blacktop. -->
